# Allied-Axis

THE PHOTO JOURNAL OF THE SECOND WORLD WAR

## Karl-Gerät 040 at the front

Panzerjäger I • SdKfz. 10 1-ton halftrack  
U.S. M2 Treadway Bridge • PzKpfw. IV Ausf. A  
Type 97 Japanese medium tank

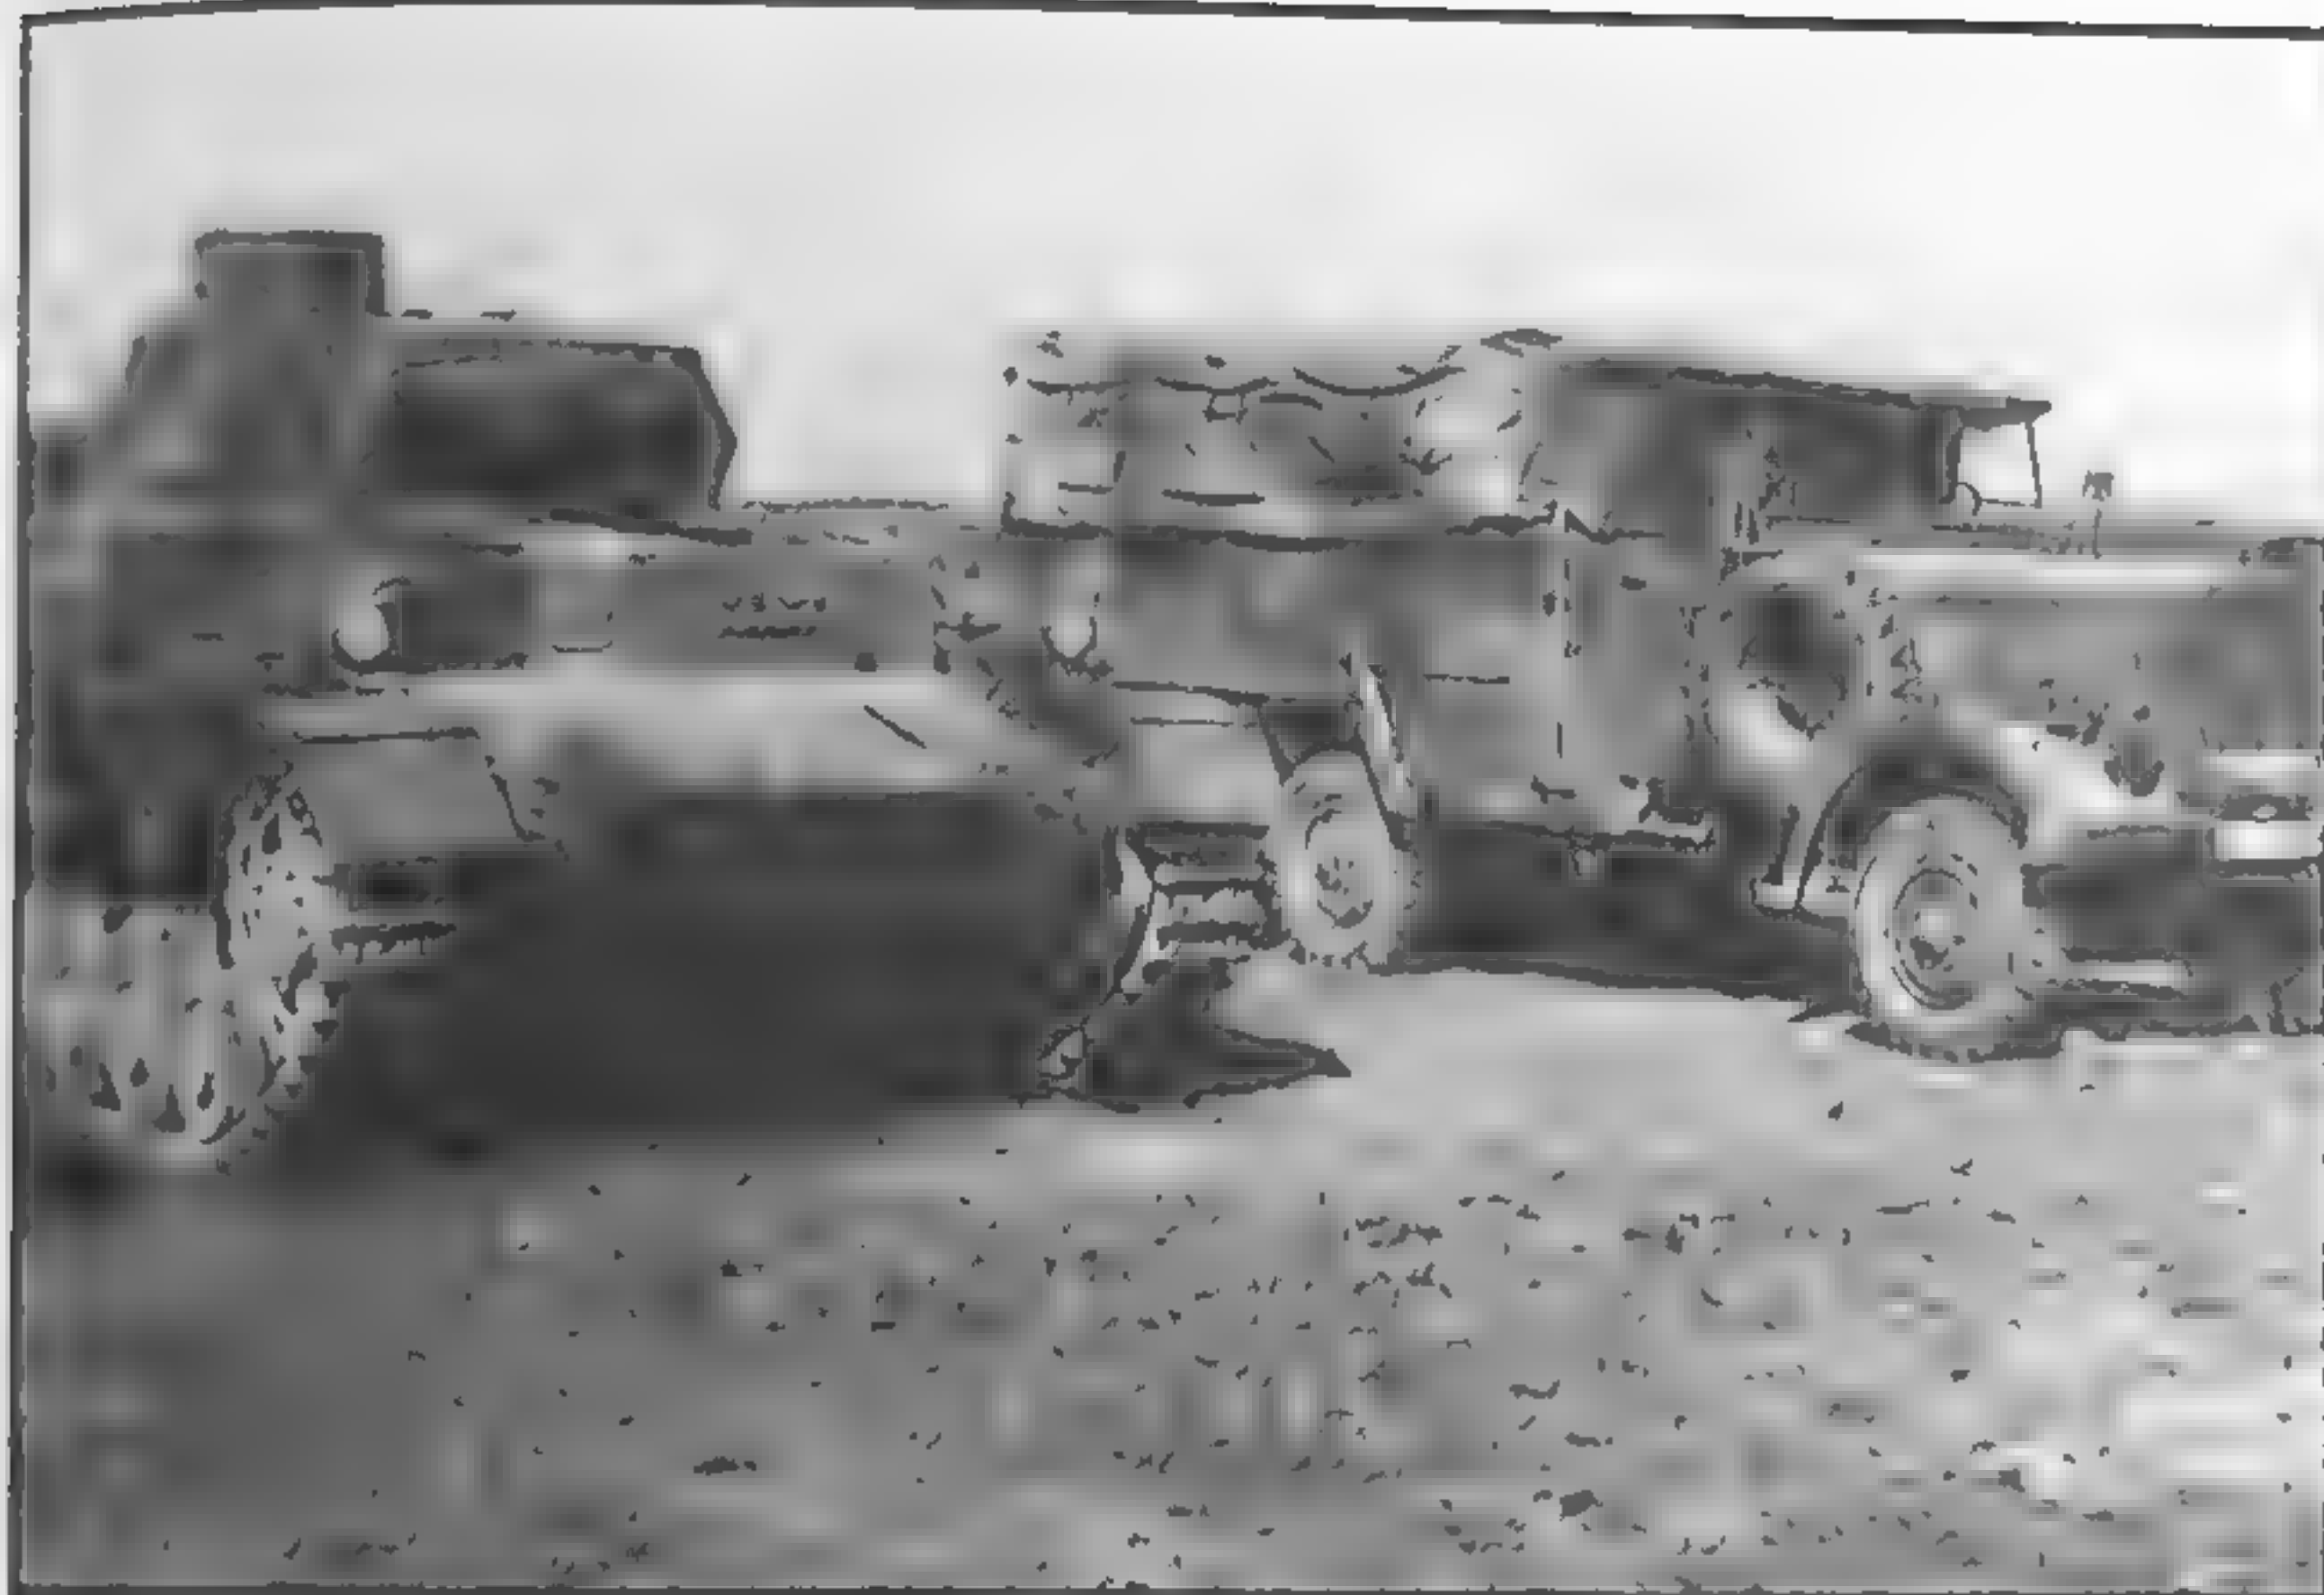
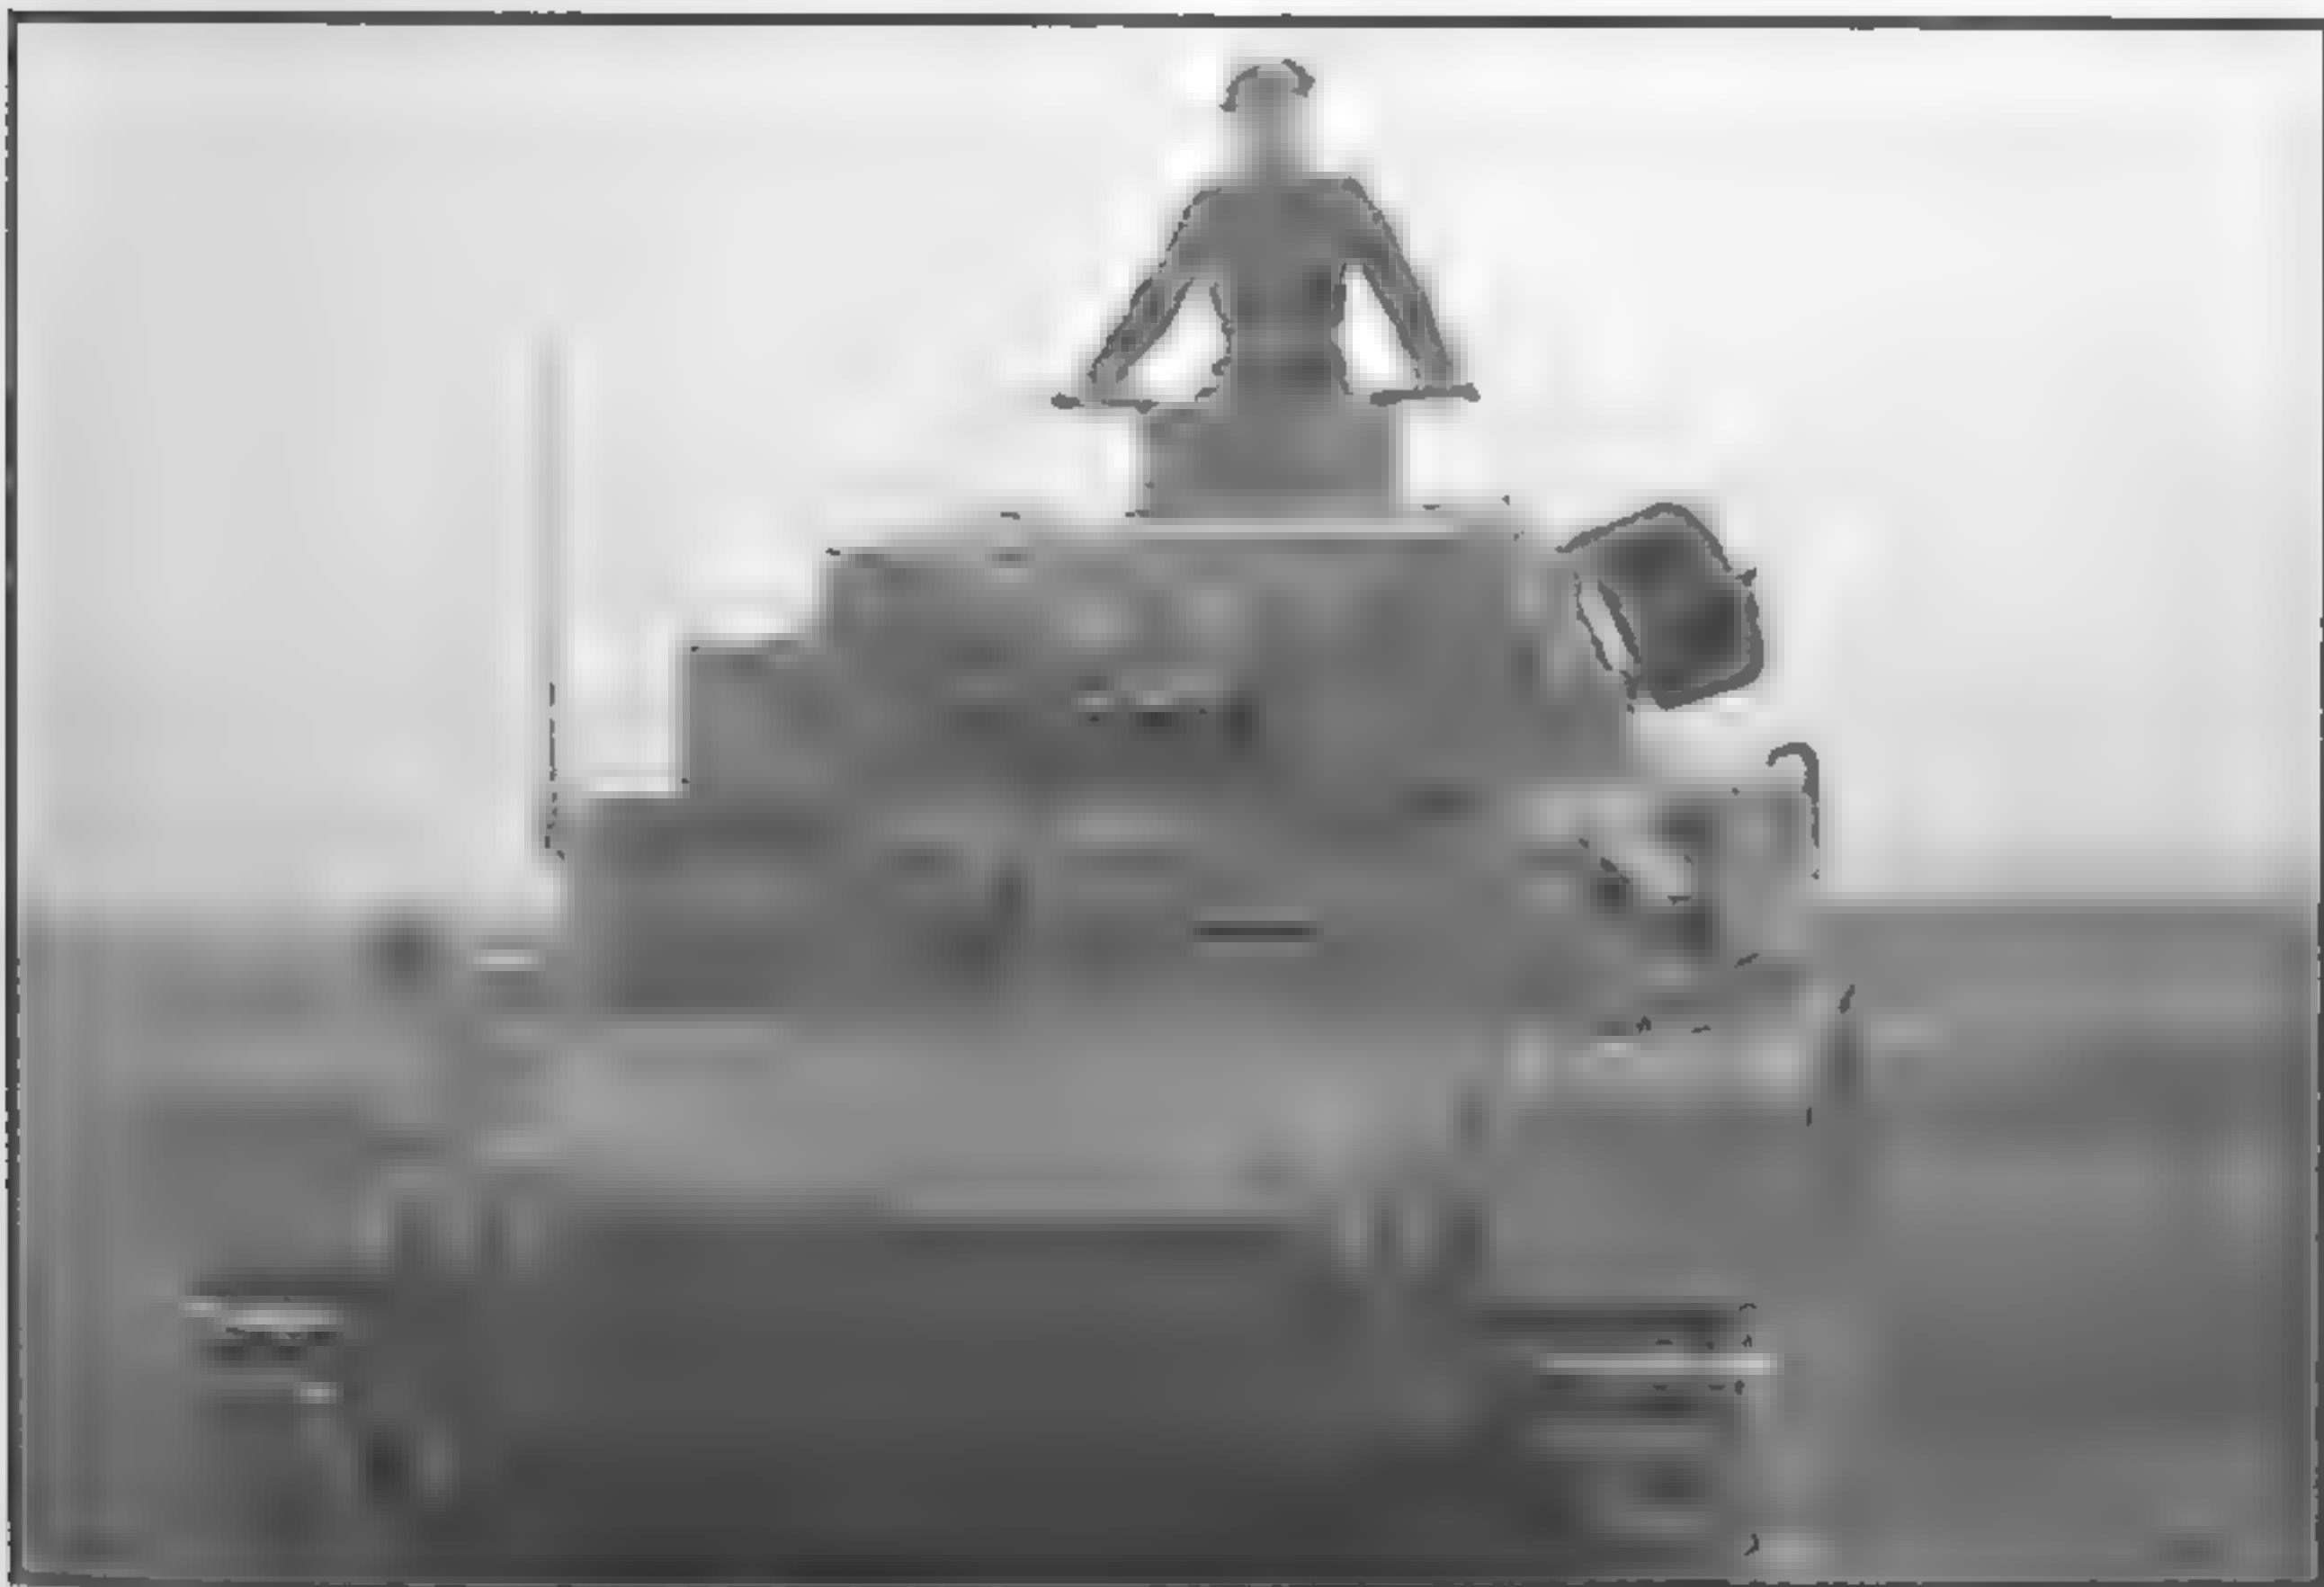
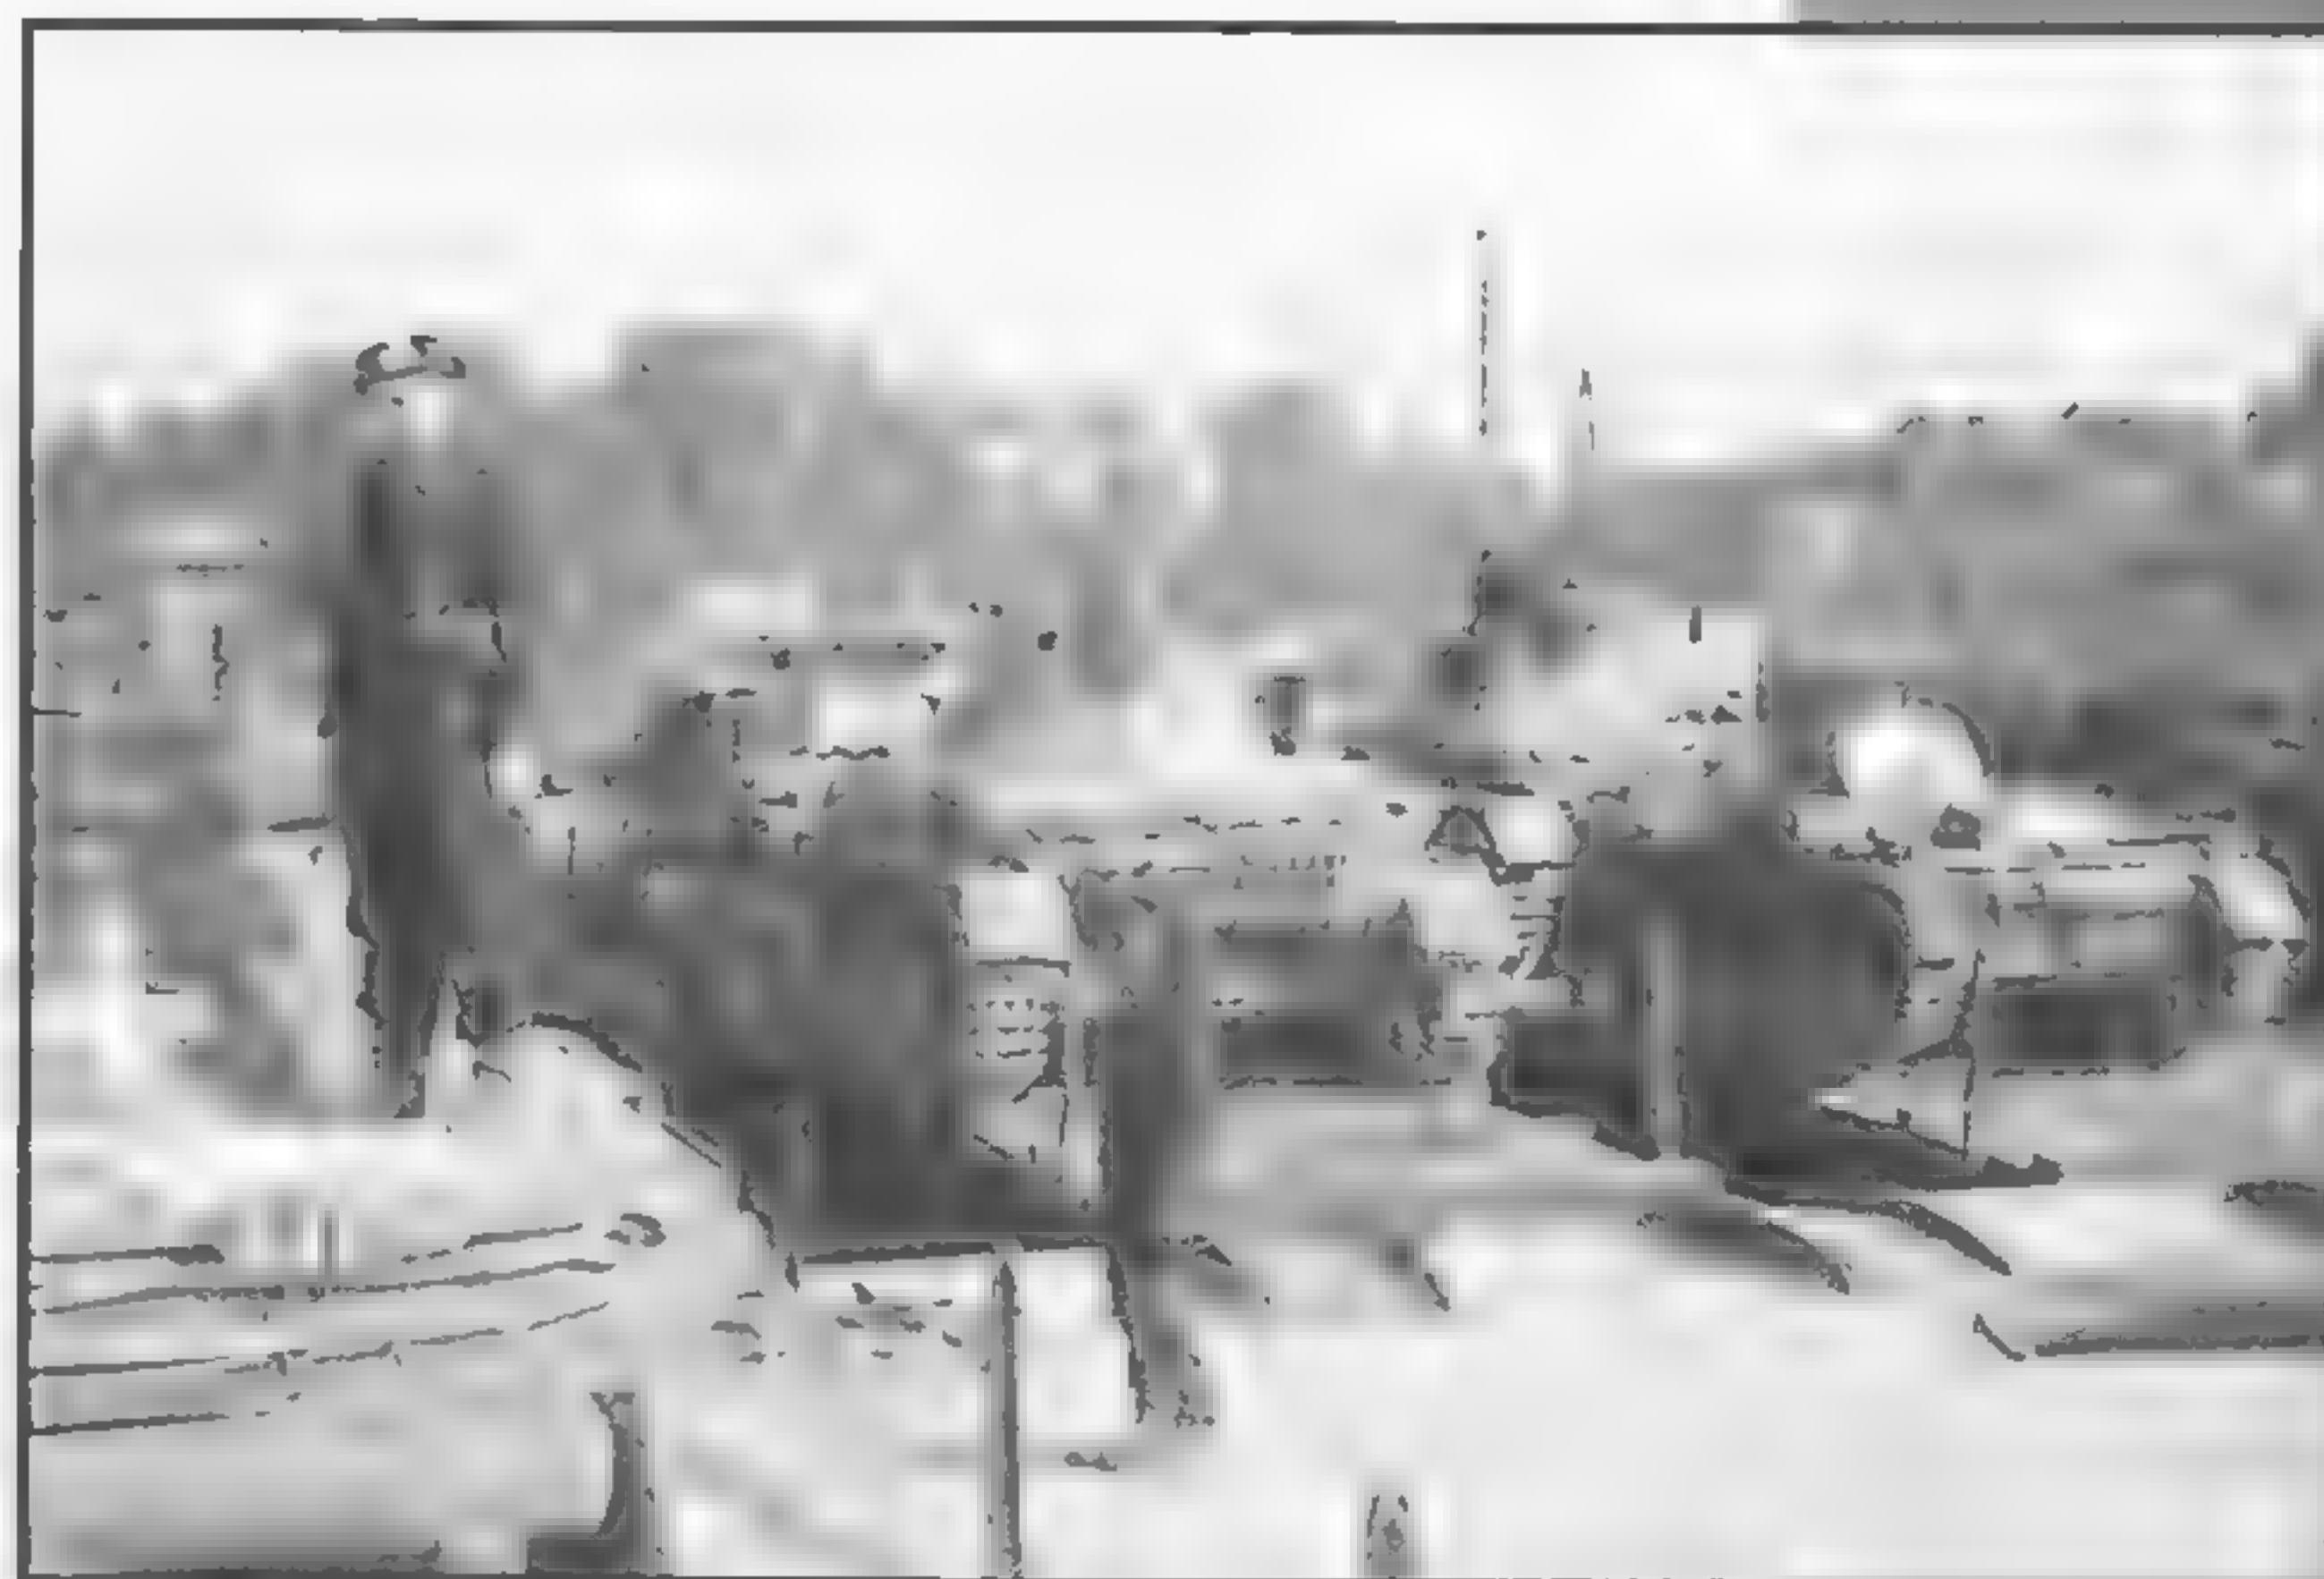
**Top left:** This Ausf. A is finished in the standard dark gray base color. The lorry still shows the earlier camouflage of green, brown, and sand. (Photo Hoppe) **Top right:** Tanks of Pz.Rgt. 6 in 1938. The first and third vehicles are Ausf. As. Again there is no further marking visible other than the tactical numbers painted on rhomboid plates. (Photo Konetzny) **Above left:** Again a tank of Pz.Rgt. 6, 1st Pz Div. The early style two-part lids for the driver and radio-operator hatches are opened wide.

(Photo DWA/Kwasny) **Above right:** The 6th company of Pz.Rgt. 6 is being entrained for transport to Poland in 1939. The fourth company of each pre-war battalion was left behind and assigned to a training and replacement battalion. Therefore, each battalion numbered the medium company with their Pz.Kpfw. IVs differently (the numbers 2, 3, 4, 5, 6, 7, and 8 were all used). Large white crosses were added for national identification before the outbreak of hostilities. (Photo DWA/Kwasny)

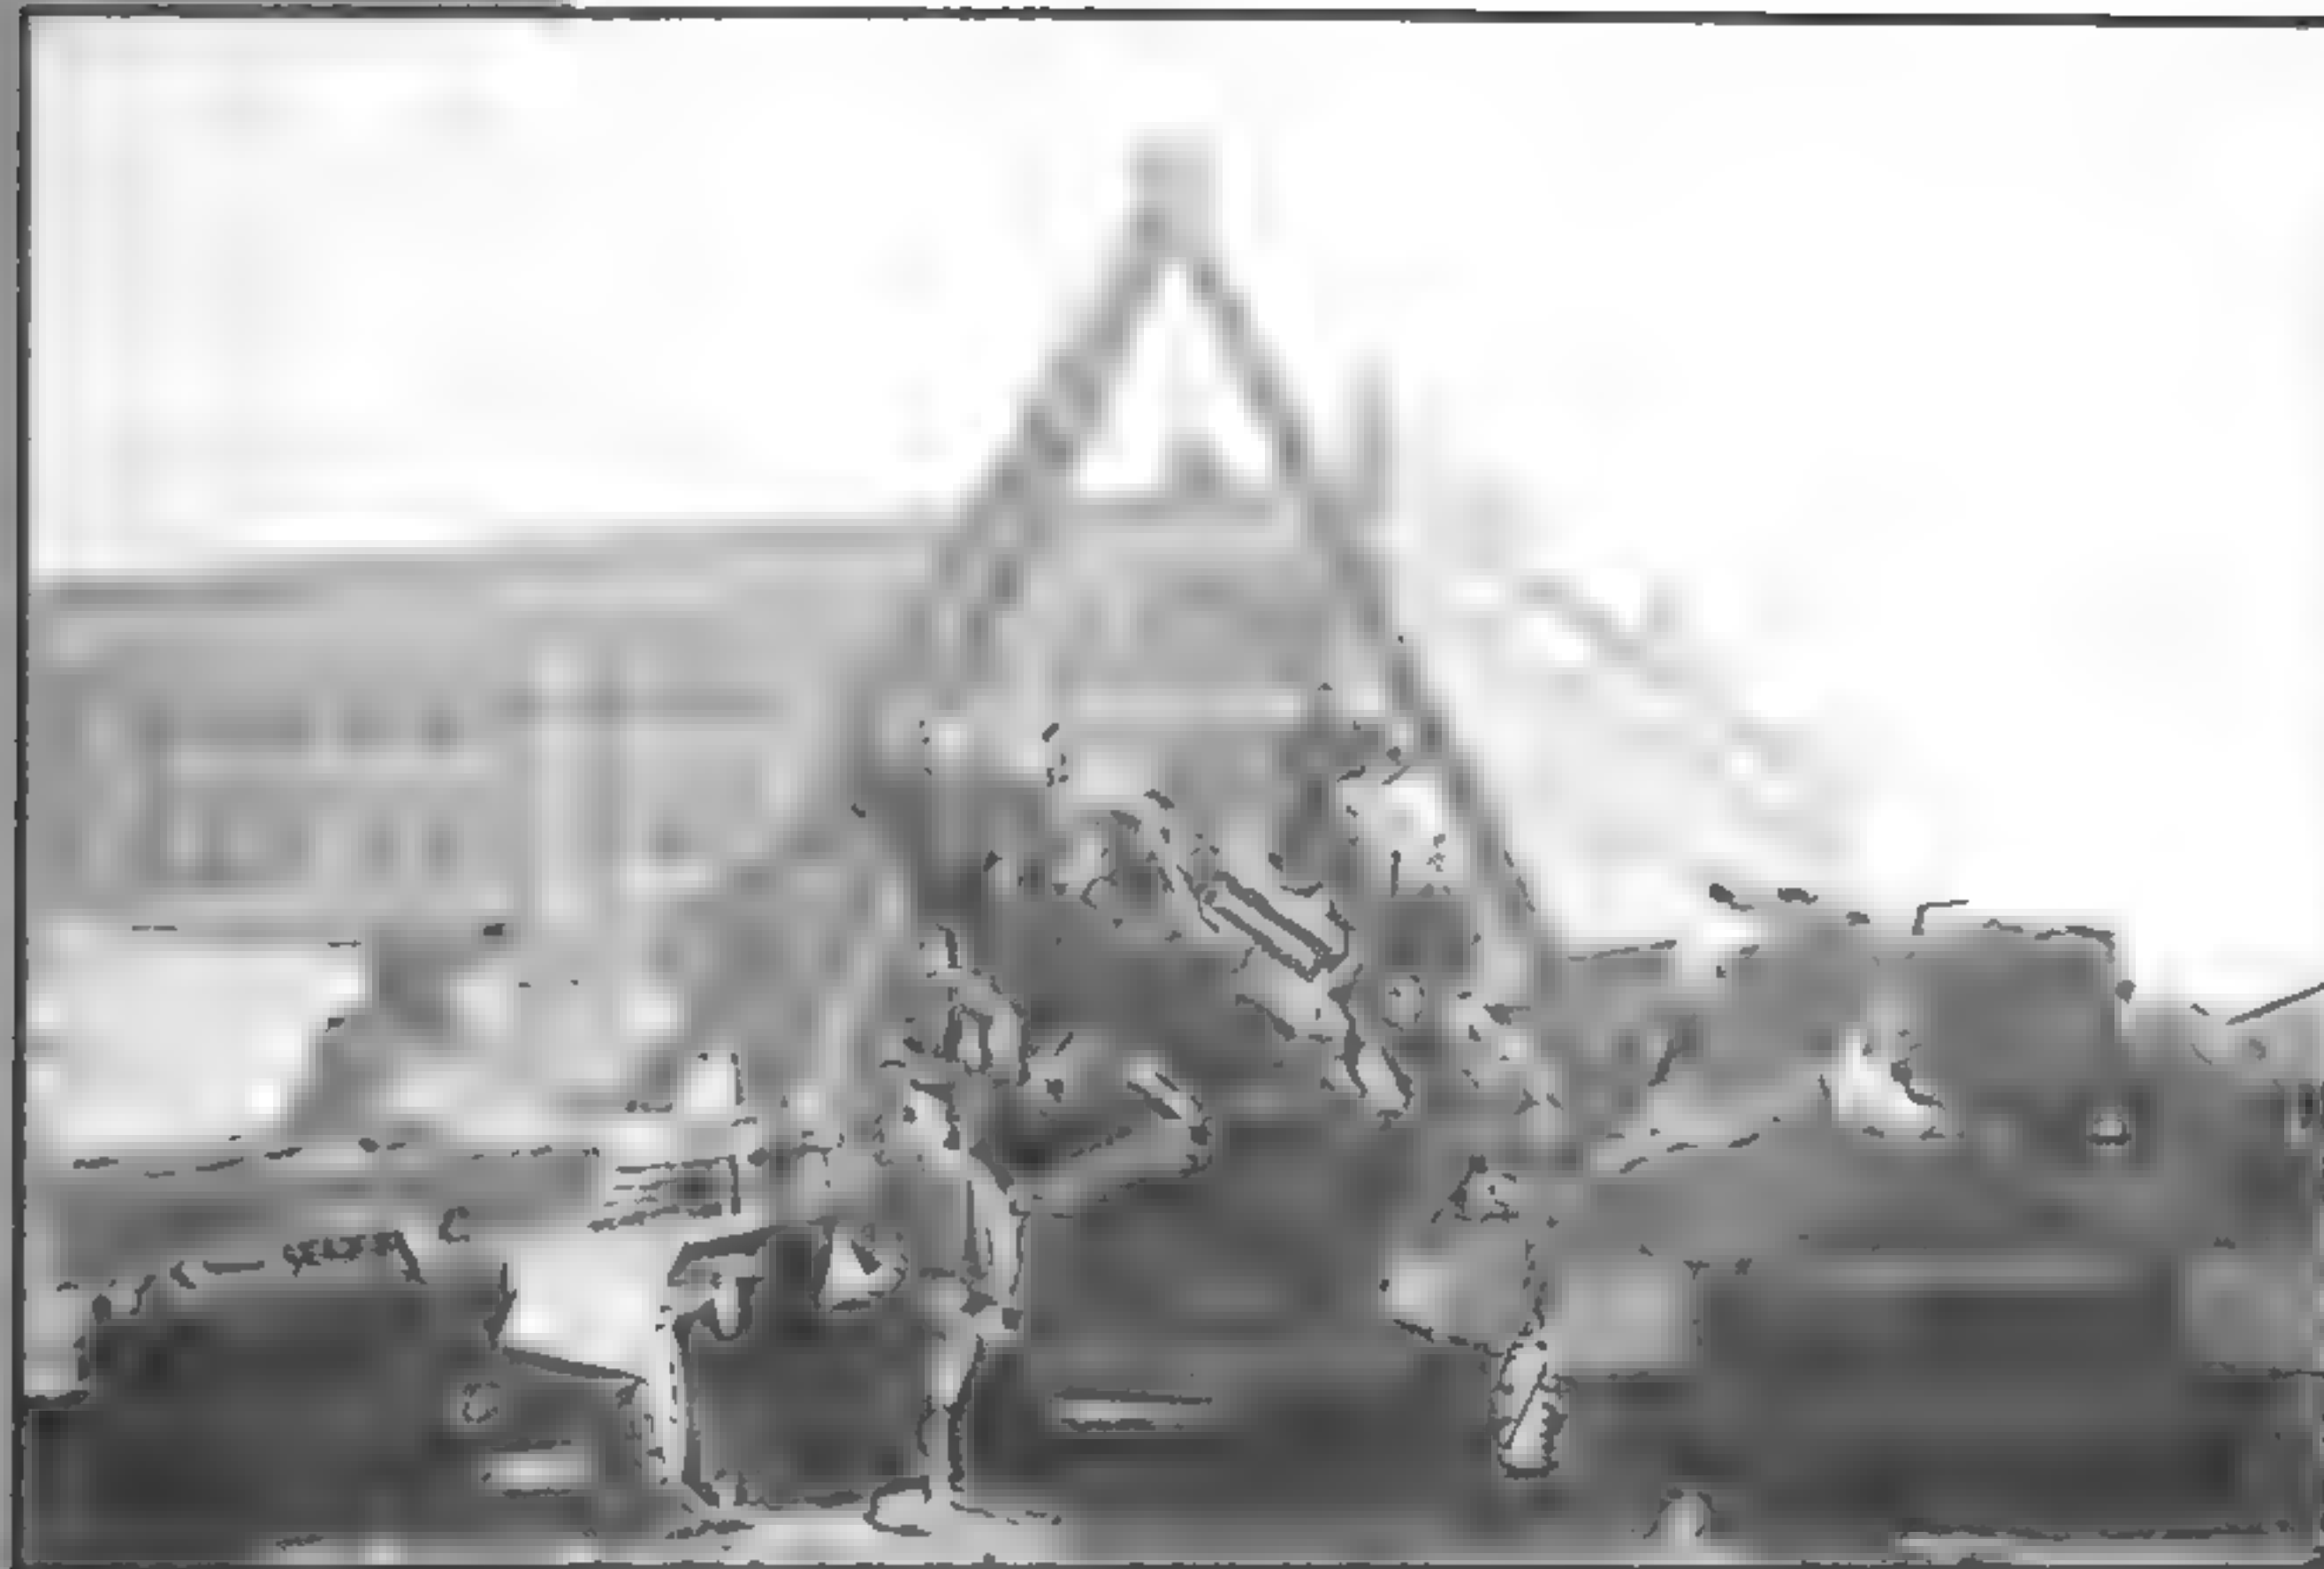
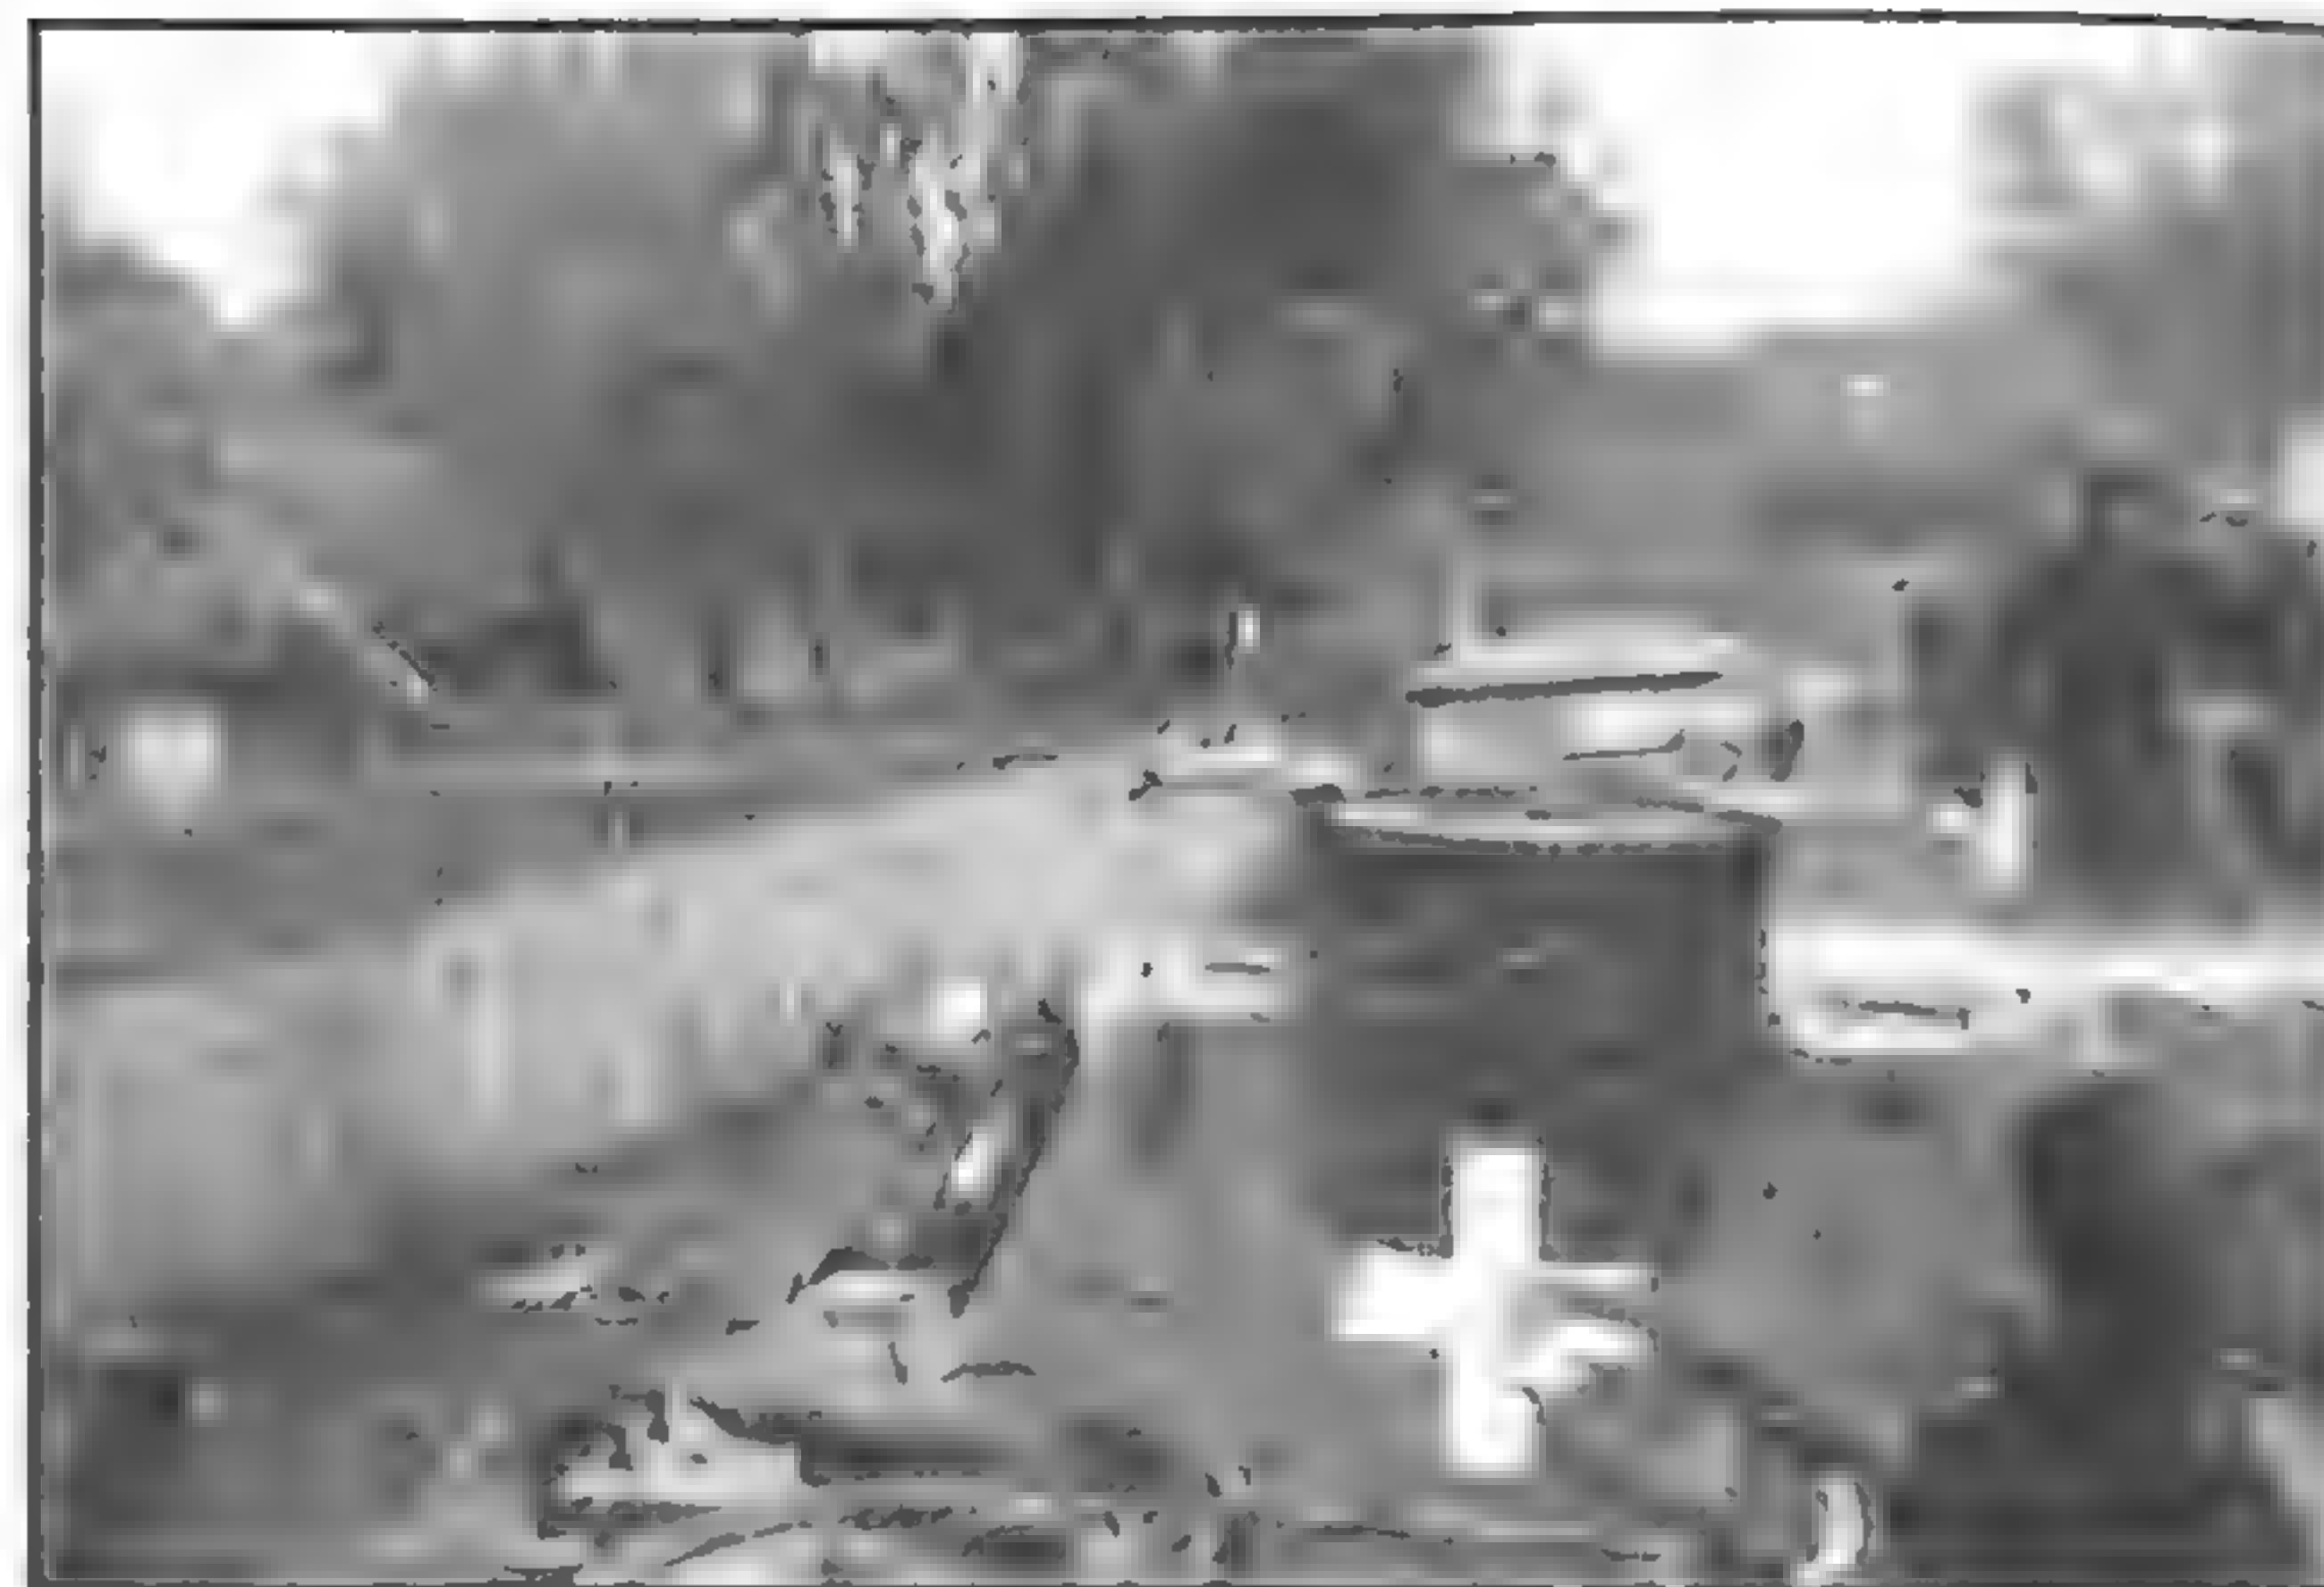
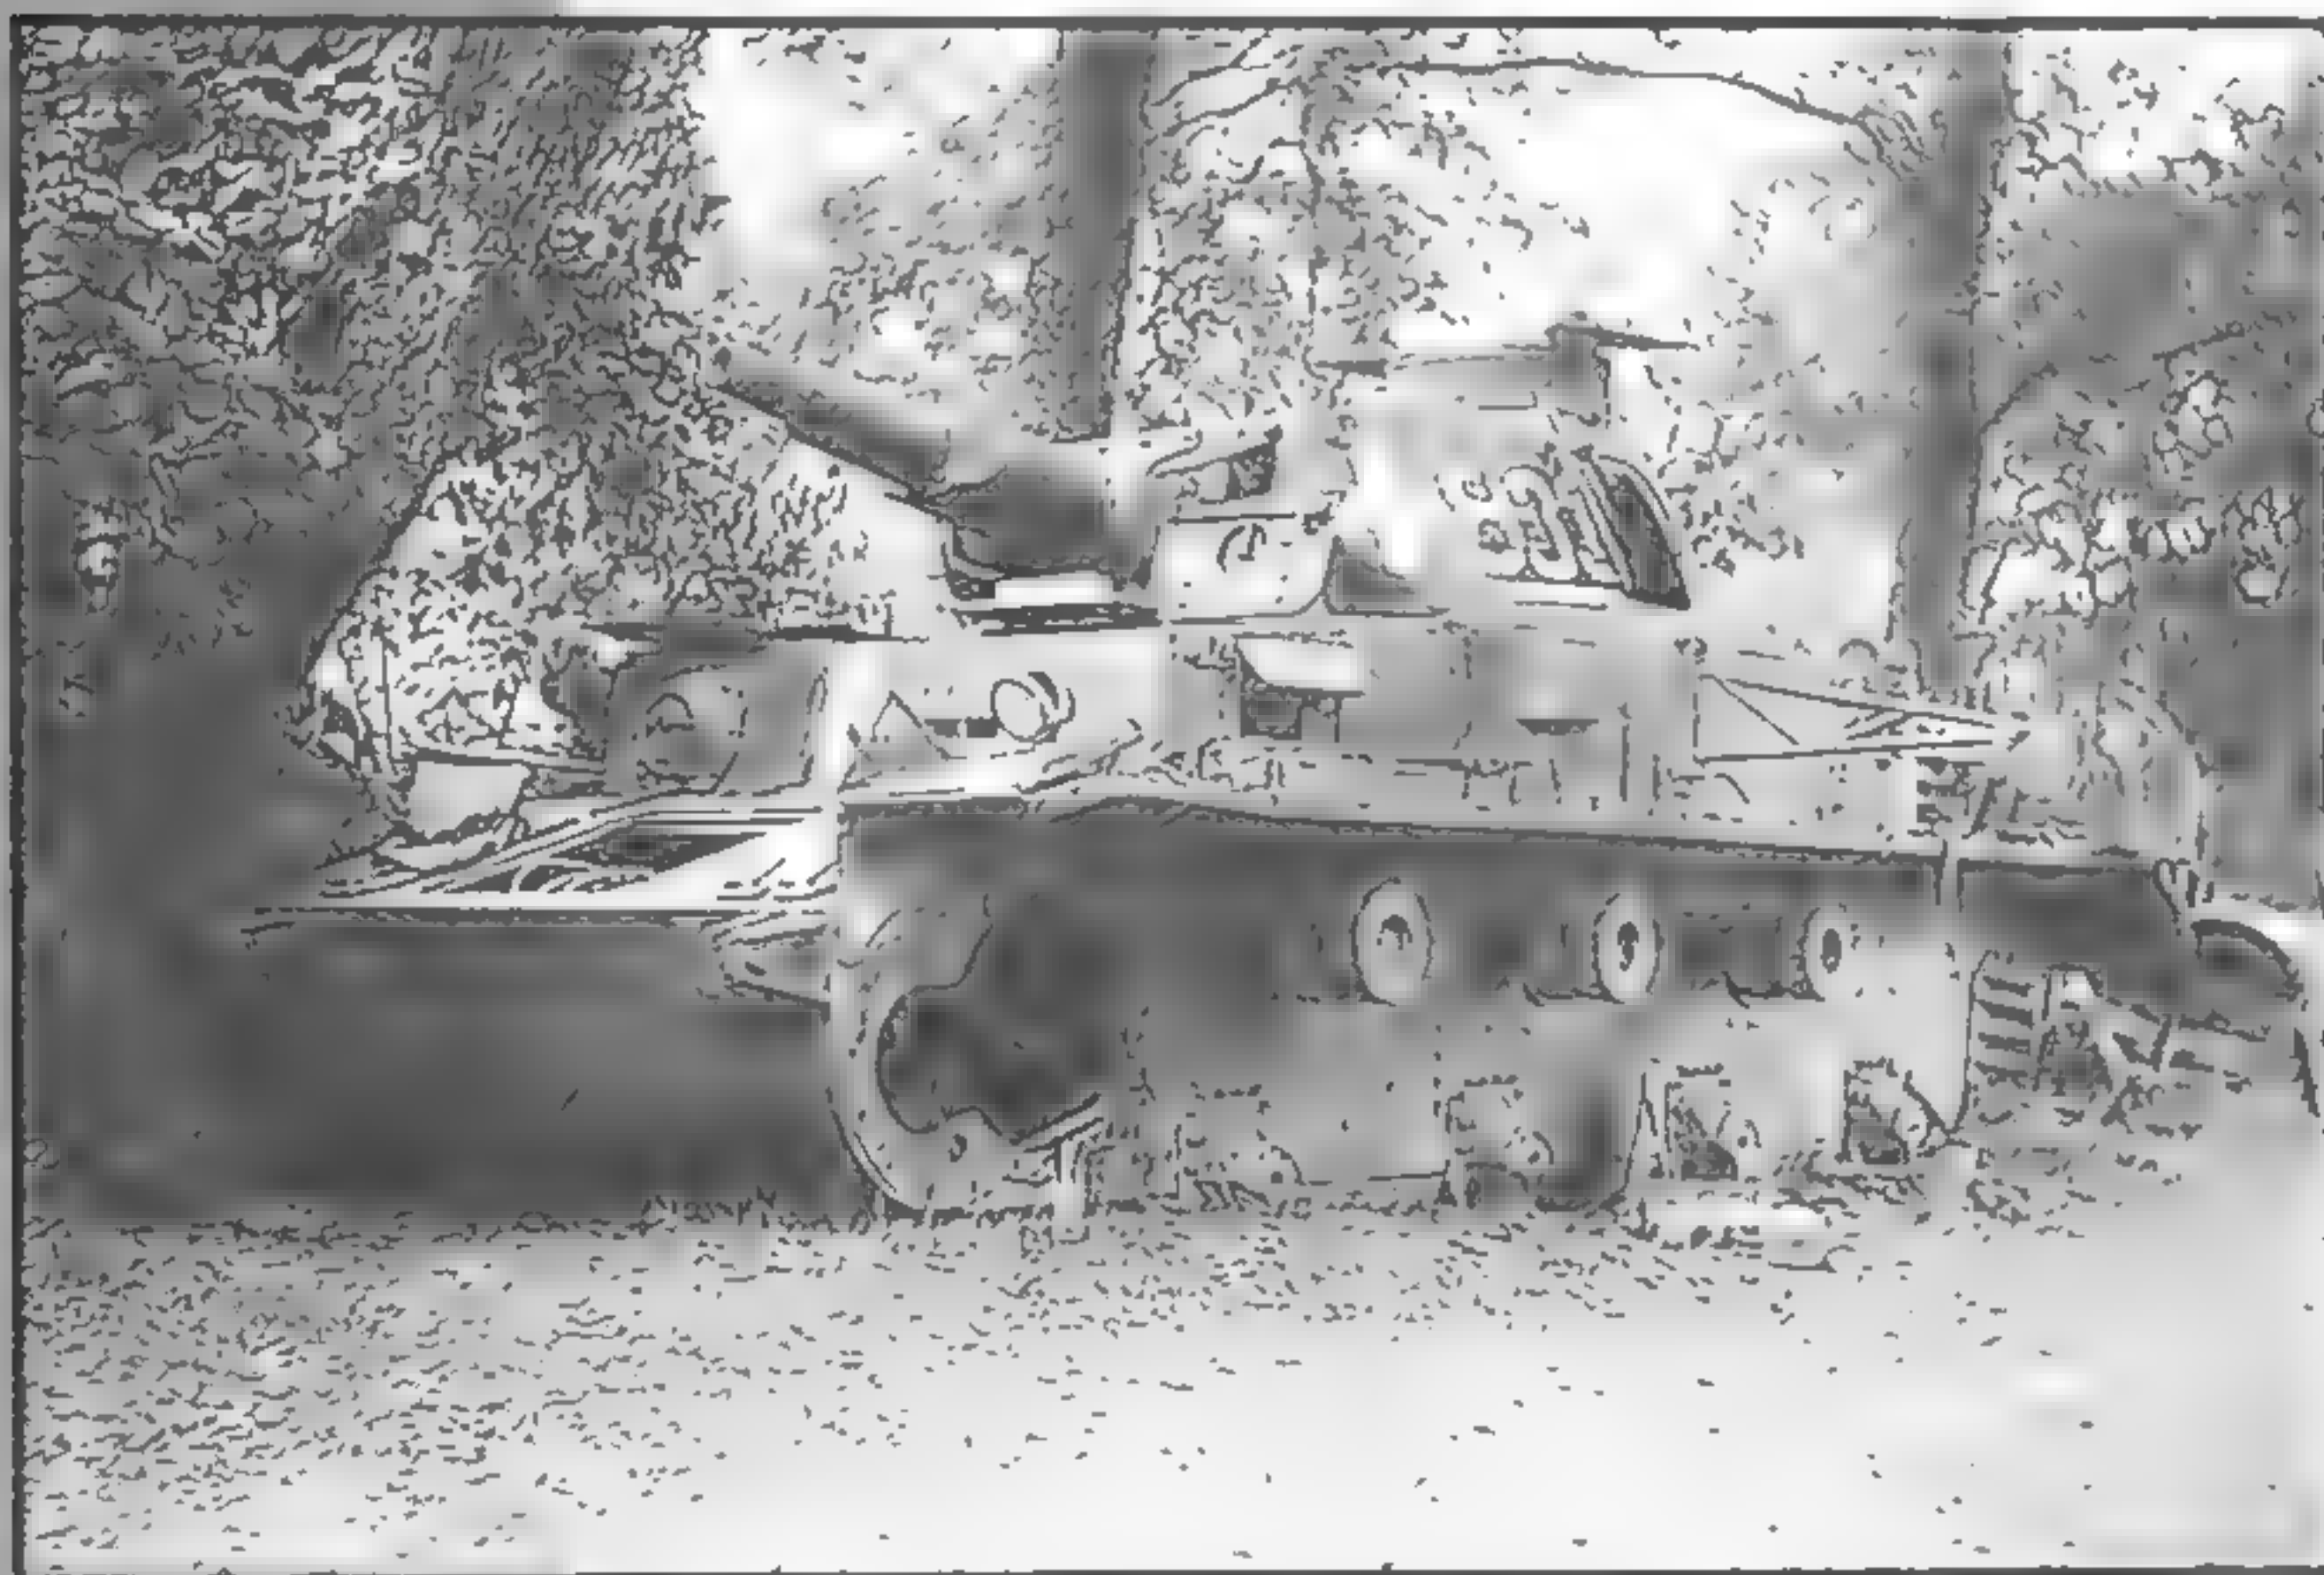
**Top left:** Using a simple wooden jib erected between two tanks, the engine of a third is being removed. These Pz Rgt. 6 tanks show minor damage from numerous hits during their first fights. (Photo DWA Kwasny) **Top right:** Note the rectangular pistol ports on the turret's rear plate. Still there are no further markings visible other than the white crosses. (Photo Konetzny) **Above left:** This completely cannibalized Ausf. A doesn't reveal significant armor damage, maybe it was hit on the other side.

Compared with the other photos, this tank shows a remarkable variety of markings. The tactical number was painted beside the white cross, underlined by a bar. This vehicle belonged to 1. Panzerdivision. (Photo S. Clark) **Above right:** Returning to Germany, these tanks of Pz Rgt. 6 can be seen during a military practice at a training ground. The white crosses on the turret sides were substituted for black Balkenkreuze on the hull's side armor, now being much less prominent. (Photo DWA Kwasny)
